Final Report:

Steelhead Creek Draft Horse Stream Channel Cleanup Project

Sacramento Regional San

Nov. 29, 2021

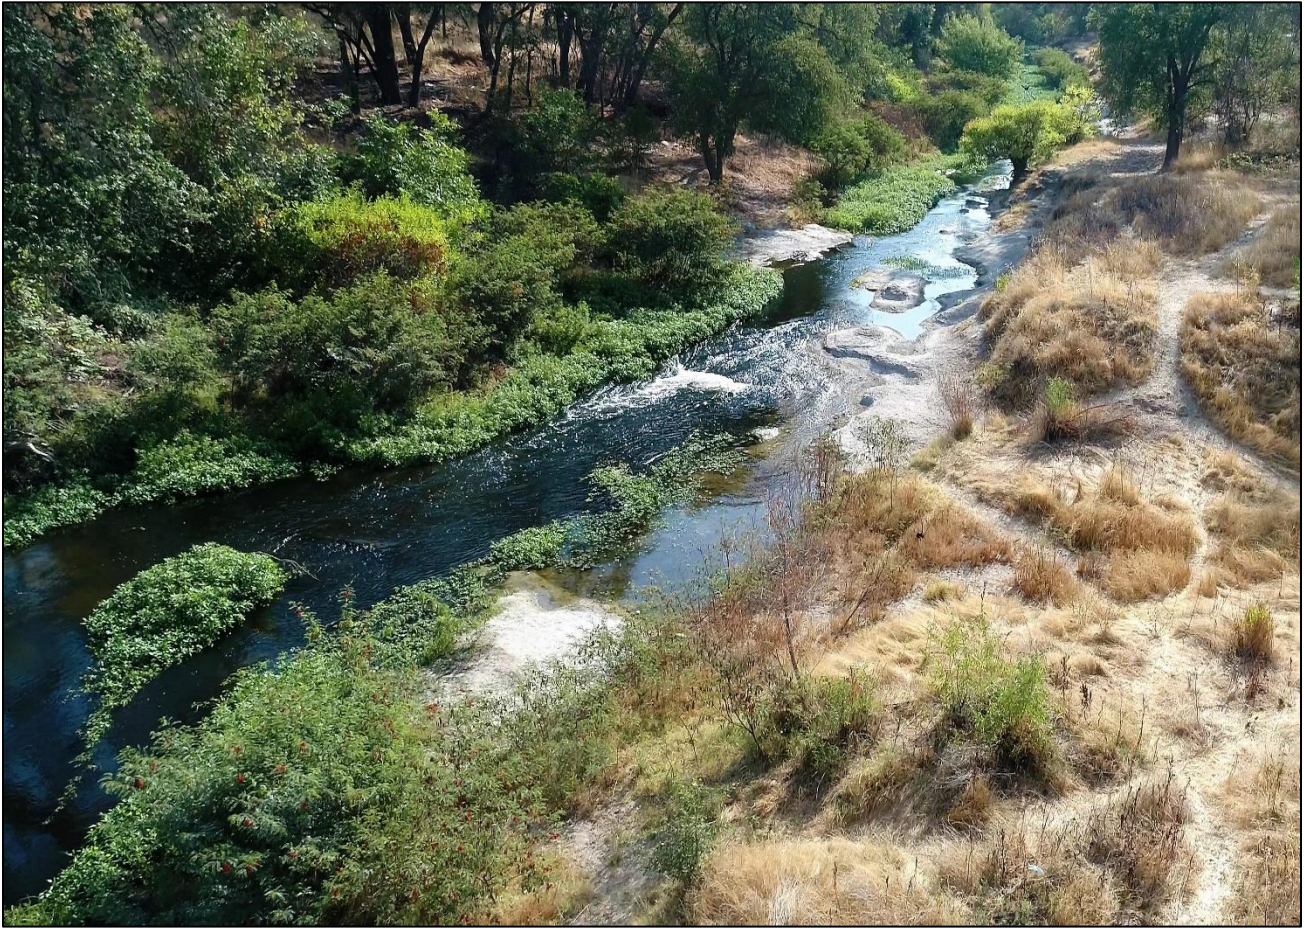
Cascades on Steelhead Creek as seen from Northgate bridge. “Island” in lower left is non-native, water primrose growing on shopping cart. Shrubbery in left foreground is invasive scarlet wisteria, removed during Project.

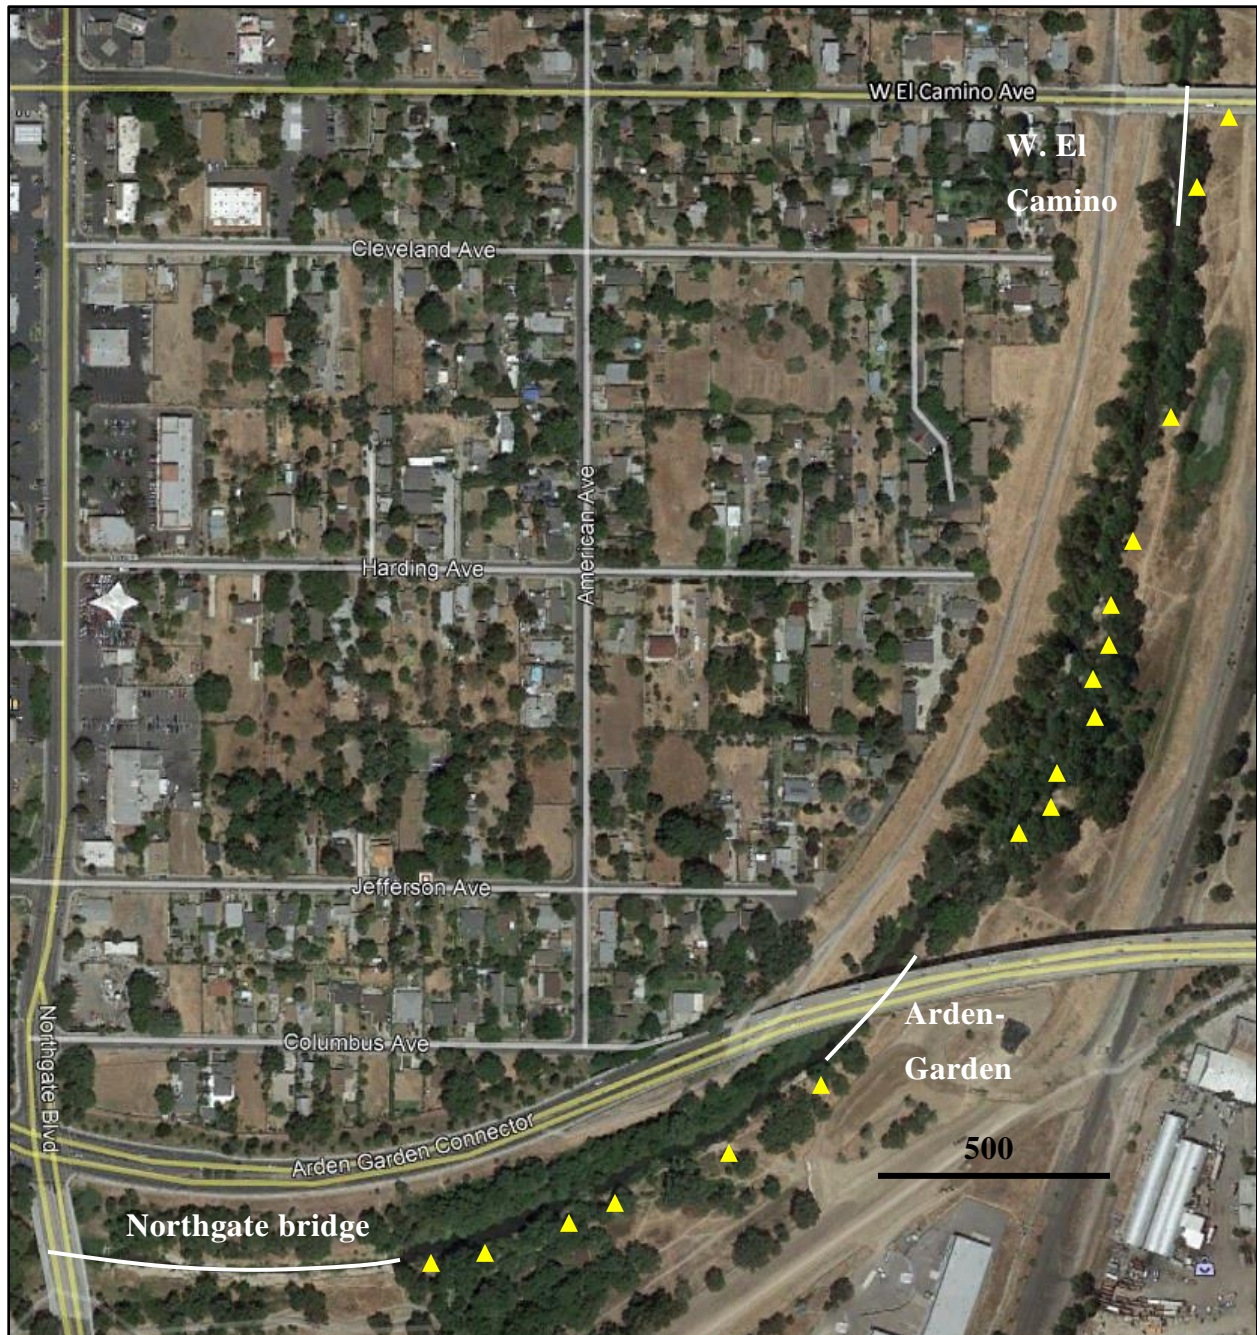
Appendix I. Location map showing three work areas along Steelhead Creek in the American River Parkway: Northgate, Arden-Garden, and W. El Camino. North to top of page. Yellow triangles indicate occupied and unoccupied homeless camps on left bank as of 23 Aug. 2021. Camps on right bank not surveyed.

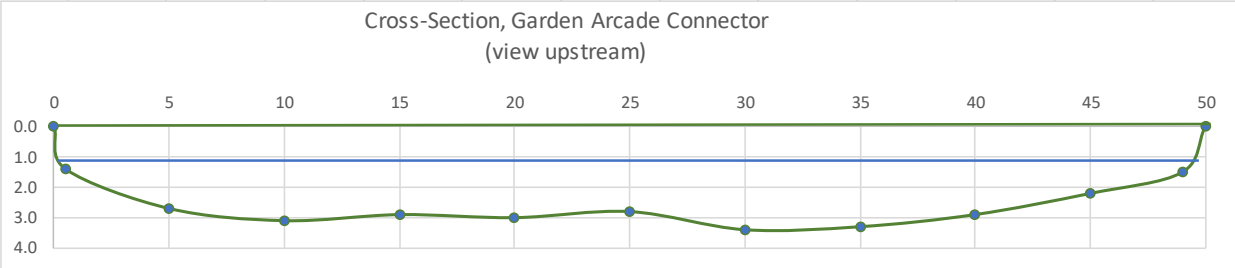
Appendix III. Cross-section, velocity, and discharge, Arden-Garden bridge showing effects of additional

Aug. 31, 0900 (blue)															
Dist	0	0.5	5	10	15	20	25	30	35	40	45	49	50	Ave.	Area
Depth	0	0.2	1.6	2	1.8	1.9	1.7	2.3	2.2	1.8	1.1	0.4	0	1.7	82.3
Sept. 1, 0800 (green)															
Dist	0	0.5	5	10	15	20	25	30	35	40	45	49	50	Ave.	Area
Depth	0	1.4	2.7	3.1	2.9	3.0	2.8	3.4	3.3	2.9	2.2	1.5	0	2.8	136.2
<div>Cross-Section, Garden Arcade Connector (view upstream)</div>

Velocity	Aug. 31, 0900		V=ft/sec	V Ave.	Discharge = Q = V * A =										
(100 ft)	1	205 sec	0.49	0.58 ft/sec	V (ft/sec)	*	A (ft2)	=	47.9 ft3/sec						
	2	141 sec	0.71		0.58	*	82.3								
	3	182 sec	0.55												
Velocity	Sept. 1, 0800		V=ft/sec	V Ave.	Discharge = Q = V * A =										
(90 ft)	1	68 sec	1.32	1.32 ft/sec	V (ft/sec)	*	A (ft2)	=	179.5 ft3/sec						
	2	70 sec	1.29		1.32	*	136.2								
	3	67 sec	1.34

The Project met an unforeseeable delay halfway through, when waters were drained from the rice fields upstream, creating unsafe or impossible wading conditions and murky water. Velocity increased from appx. 0.6 ft/sec to 1.32 ft/sec, and discharge from 48 cfs to 180 cfs (Appx. III). We had anticipated the draining to occur later in October, and scheduled the Project to be completed by then. But due to the drought, the drainage occurred a month ahead of schedule, so we had to put the Project in abeyance for three weeks until safe conditions returned.

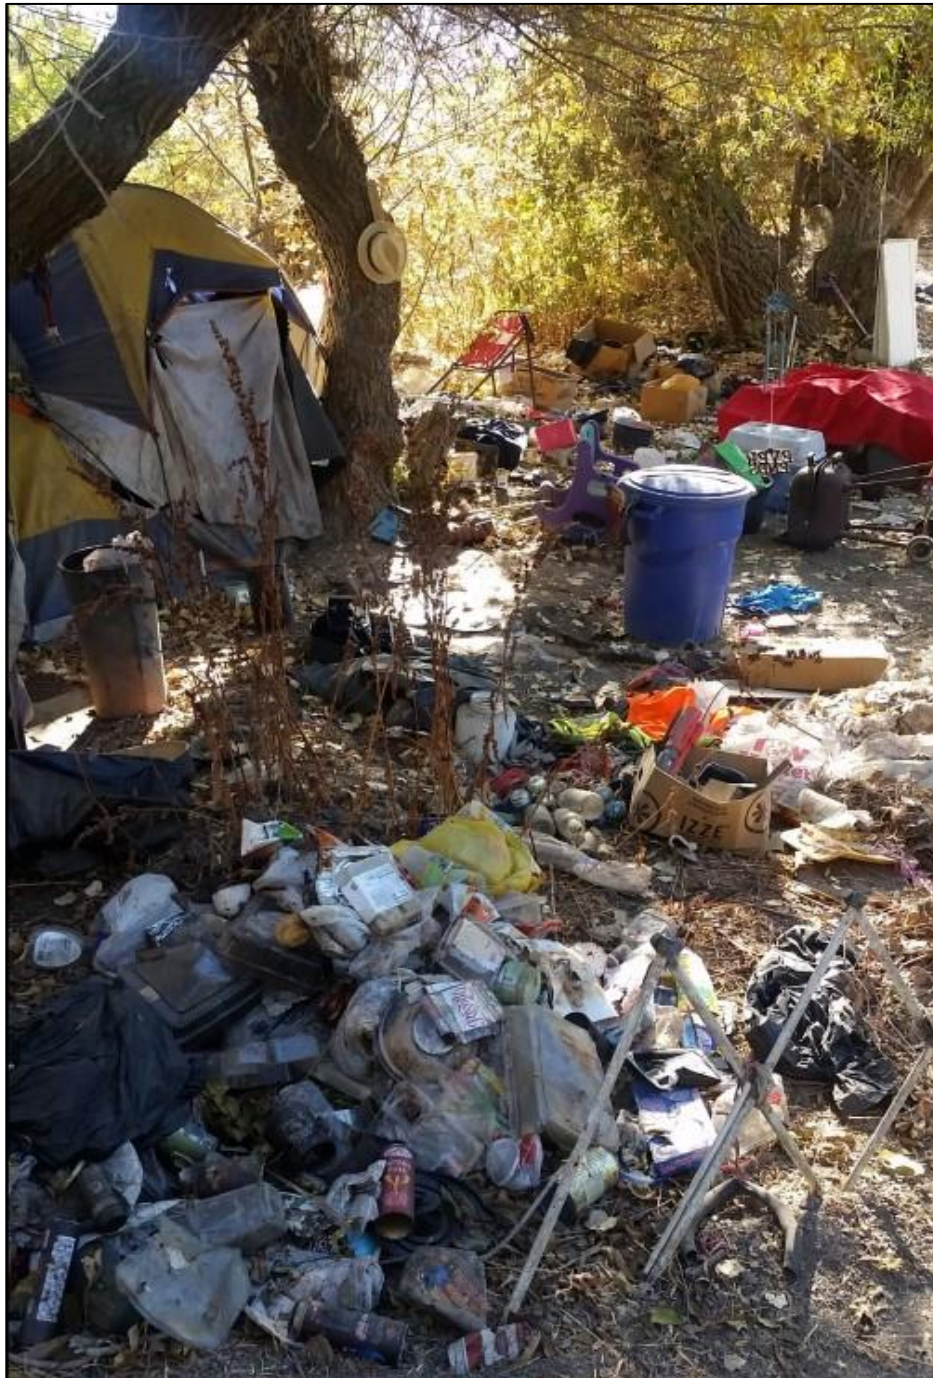
Photo 1. Abandoned homeless camp on Steelhead Creek at “The Grove” in the middle of the Project area between Arden-Garden and W. El Camino bridges. Camp has since been cleaned out.

Years of neglect, illegal dumping, and recently, uncontrolled homeless camping have caused tons of solid and hazardous waste to be deposited in the channel, damaging its ability to sustain life there (Photo 1, Video 1). Large debris, particularly shopping carts, form islands where floating debris and water primrose accrete on them, obstructing fish passage and reducing water conveyance capacity. Other debris, like mattresses, tires, and textiles, armor the channel bottom, impeding access to burrowing organisms, and creating an anoxic dead zone in which no organisms survive.

Unfortunately, years of ecological neglect, illegal dumping, and the latest threat—uncontrolled homeless camping—have significantly damaged Steelhead Creek (Photo 1). Because of its attractive natural setting, the riparian corridor has become the epicenter of squatting, and related impacts have pushed the creek's aquatic habitat to its tipping point through discharge of solid and toxic waste (including human feces); trampling and removal of vegetative understory; increased bank failure and sedimentation into the creek; accumulation of debris in the channel; and increased water temperature through destruction of over-story trees.

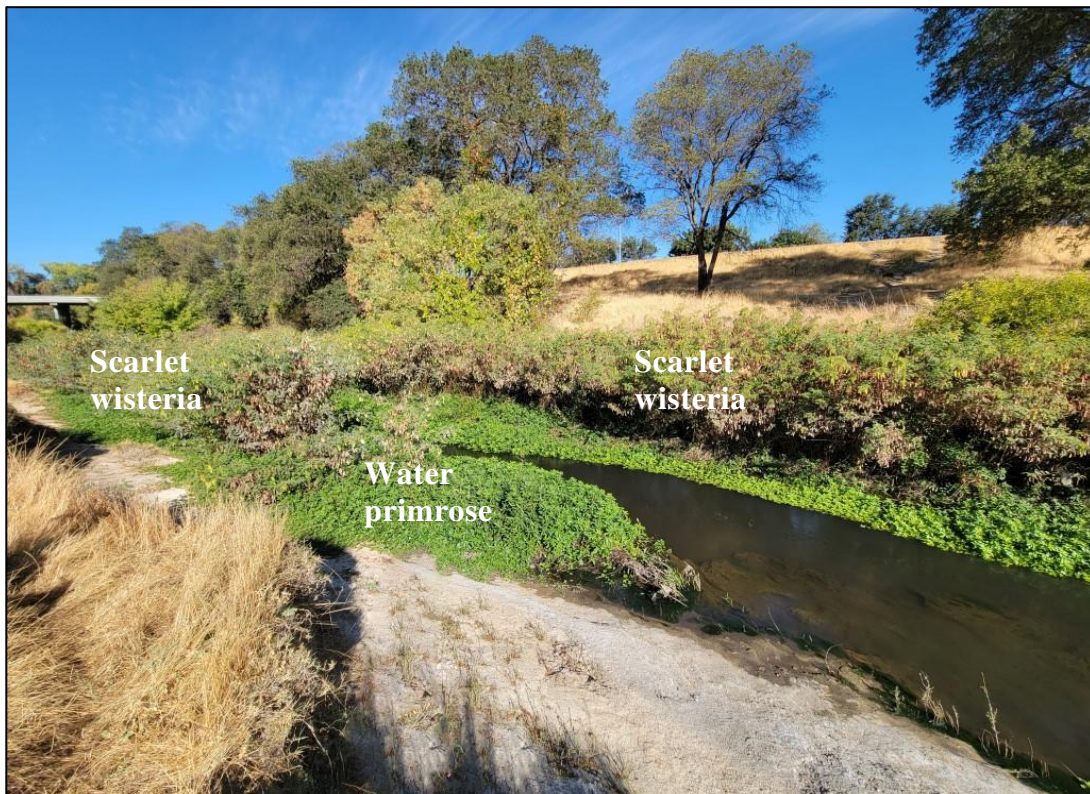
Photo 2. Scarlet wisteria lines the banks of Steelhead Creek and water primrose clogs the channel's surface. Wisteria displaces native riparian vegetation and primrose impedes fish passage and obscures light penetration. View downstream; Northgate bridge in background.

Invasive non-native scarlet wisteria trees line the banks, trapping debris and displacing native vegetation (Photo 2). A recent proliferation of water primrose has grown into dense mats, in places completely blocking the channel, impeding fish migration, trapping debris, and preventing light from penetrating the water (Photo 3).

Scarlet wisteria (*Sesbania punicea*) is an invasive, non-native deciduous shrub or small tree (family *Fabaceae*), that grows up to 12 ft tall (Photos 2, 5). It goes to seed in late summer and fall. Reproductive individuals produce 100-1000 seed pods/year, with 5-10 seeds/pod. Reproductive output can approach 100 seeds/square foot. Germination rates are over 90%.

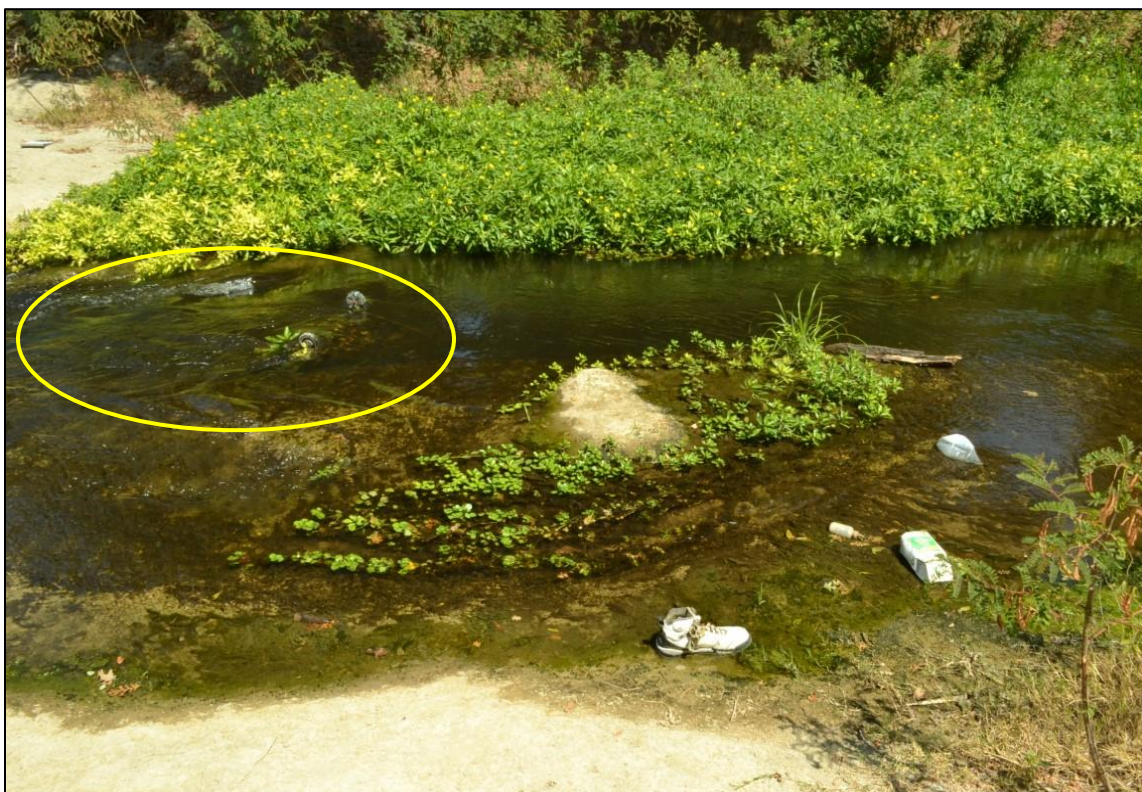
Photo 4. Debris trapping. Shopping cart embedded in channel collects flotsam. Note encroaching primrose on far bank.

Debris trapping occurs when large, solid debris, mainly shopping carts, office chairs, and bicycles, are thrown into the channel (Photo 4). There, they trap natural flotsam such as wood and aquatic plants, and textile debris, accreting initially to form islands, then peninsulas. In Steelhead Creek, aquatic primrose grows on these structures, progressively enlarging the obstructions and trapping more debris until, in places, nearly the entire channel is obstructed, posing a barrier to fish passage and reducing the channel's flow conveyance capacity, which leads to flooding and bank erosion (Photo 5). Adjacent to the Arden-Garden bridge, one such peninsula formed on a shopping cart and a trapped carpet remnant, extended from the bank 20 ft into the channel, and reduced the normal-flow conveyance capacity by 40 percent.

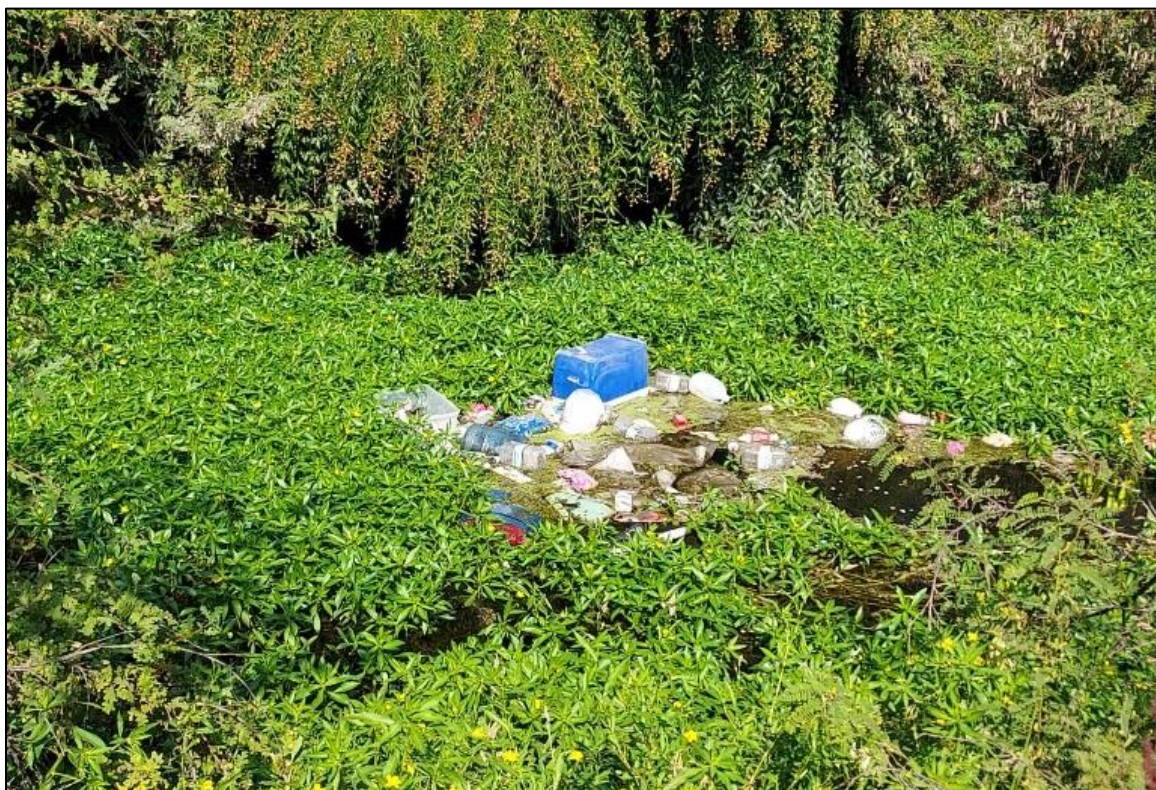
Photo 5. Primrose completely covering channel, impeding fish passage and trapping debris.

Uruguay water primrose (*Ludwigia hexapetala*) was originally introduced as an aquatic ornamental and is now a scourge of many waterways in the Central Valley (Photos 3, 5). Established some 25 years ago, it has grown exponentially in the past several years. The plants form dense mats above and below the water surface, anchored on thick stalks attached

Scarlet wisteria grows as bushy shrubs or small trees, and at the time of this Project, were full of seed pods (Photos 3, 5). Care must be taken when disturbing wisteria that its seeds are not spread or knocked into the water, since they are readily dispersed and have a high germination rate. To minimize this, we formed three-person crews: one would hold a branch while the other would cut it off about three feet from the base using pruning loppers, and a third would gently place it onto a 12 ft x 15 ft heavy-duty tarp that was spread out on the ground. Once the tarp was “full” (between two and ten bushes depending on the size), the tarp was wrapped over the branches and secured, and the bundle carried (across the creek if necessary) to the disposal site, where it was dumped. The bundles were light and easily carried by two or three people.

Primrose grows as dense mats in places, completely choking out the stream (Photos 3, 5). Removing it by hand involved wading into (shallow) water, reaching as deeply as possible to get closest to the root mass, grabbing a handful of the stalks, and pulling out the mass, which

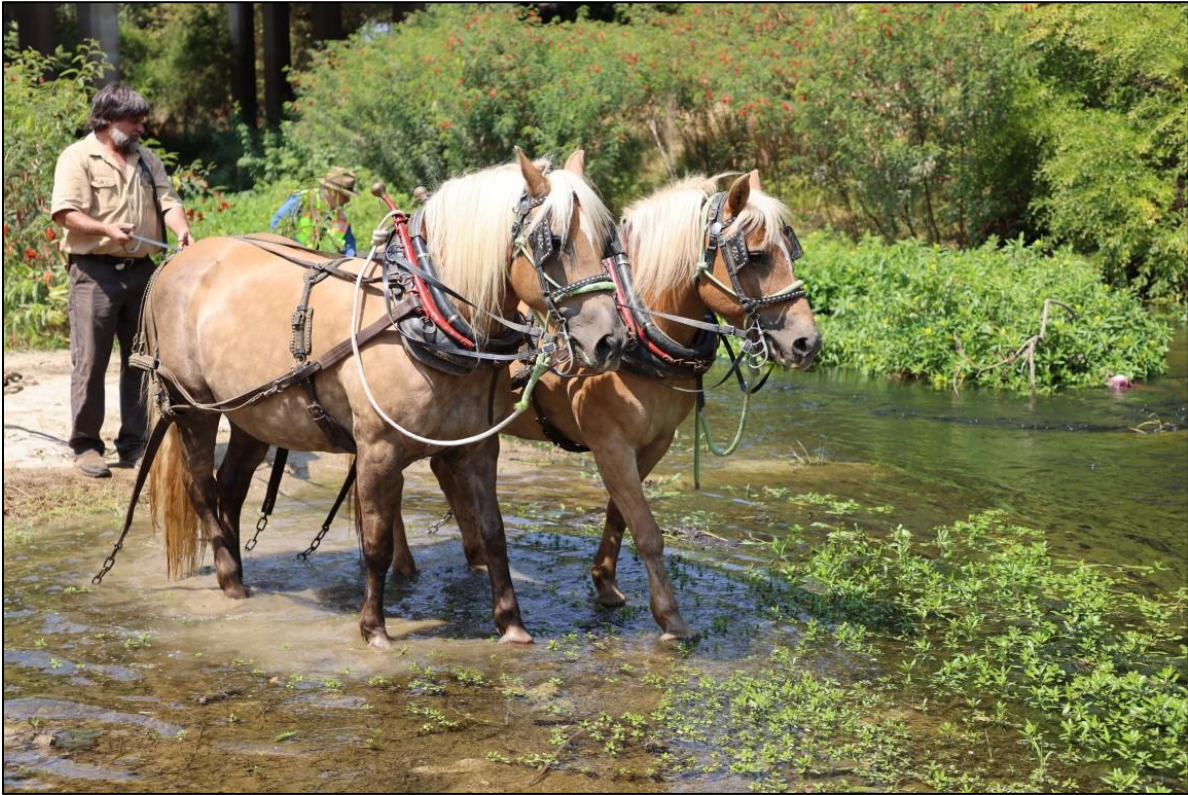
Photo 6. Draft horses Belle and Star and teamster Scott Borello worked successfully in areas not accessible to powered machinery. Photo by Kathy Kayner.

Our previous surveys have demonstrated that between 0.5 and 1.5 hours are needed to manually remove large tires, embedded shopping carts, or a saturated mattress (which weighs over 850 lbs). Cleaning a 15 ft x 20 ft site can take over 6 hours by hand due to the embeddedness, weight, and sheer volume of debris, so is clearly not feasible. Using machinery is problematic due to the difficulty accessing the channel and its significant impact on the habitat. So, to remove debris and invasive vegetation in the water and on the banks, our Project employed a team of draft horses and a hand crew, thereby avoiding the impacts of powered equipment (Photo 6).

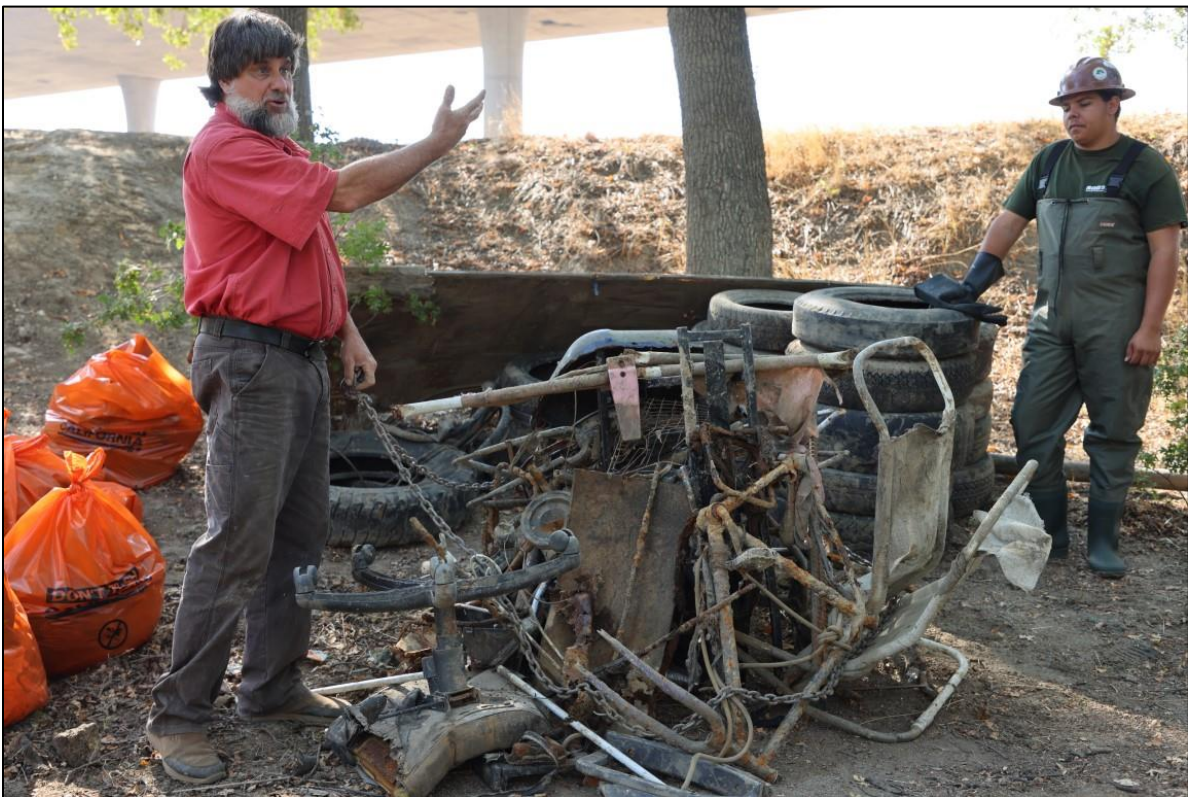
Photo 7. Large debris removed by horse team from the channel of Steelhead Creek. Scott Borello explaining safety measures. Photo by Kathy Kayner.

The main types of large debris in the channel of Steelhead Creek are shopping carts, tires, mattresses, and (probably stolen) bicycles (Photo 7). Shopping carts, and to a lesser extent,

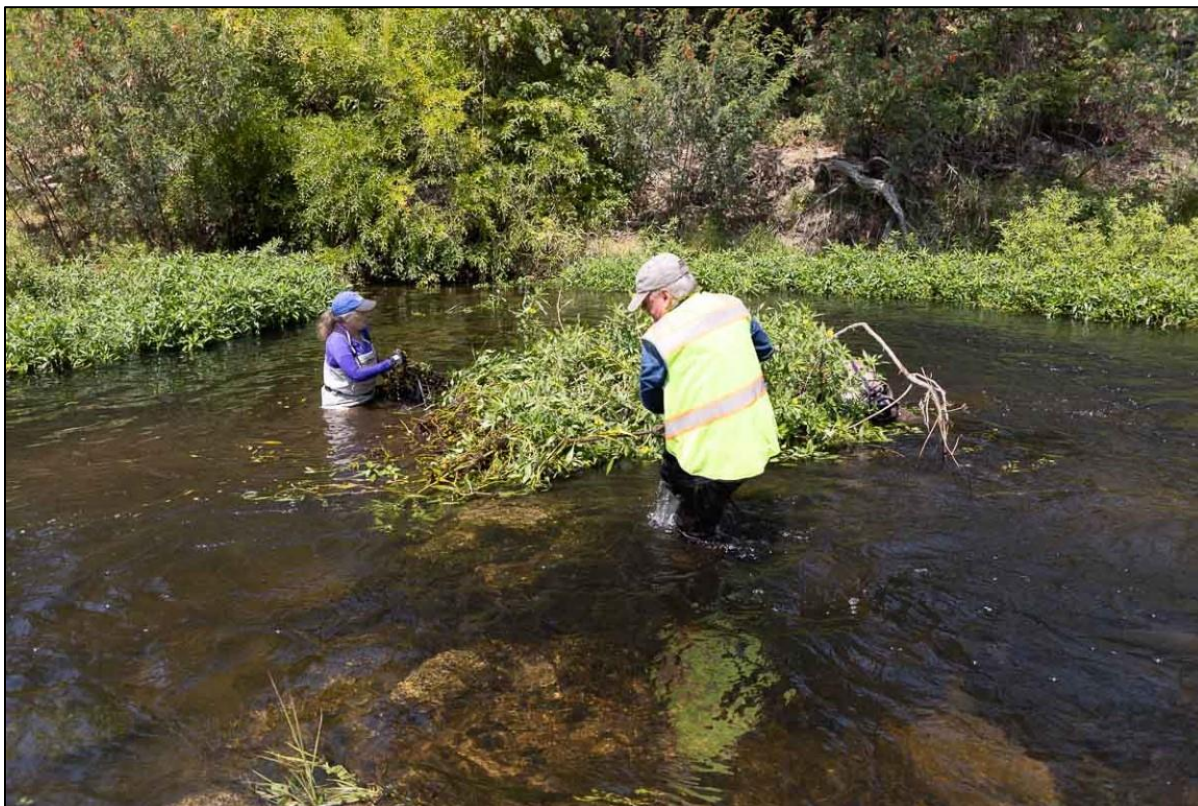
Photo 8. Island in middle of channel has formed on embedded shopping cart entangled in primrose. Photo by Kathy Kayner.

When embedded in the sediment, shopping carts are often impossible to remove by hand because they are usually entangled by the primrose (Photo 8). Weighing 40-60 lbs each and being very awkward to maneuver, even non-embedded carts are still difficult to pull out by hand, especially where the bank is steep. However, they were handily removed by the horse team. Ropes or chains were attached to the wheel frame—the strongest structural member of the cart. Although sometimes they had to pull 3-4 times, the horses were able to pull out the most recalcitrant carts, even though some were so rusted they broke apart. Some required crew pulling on “tag lines” to prevent the carts from getting stuck on the bank.

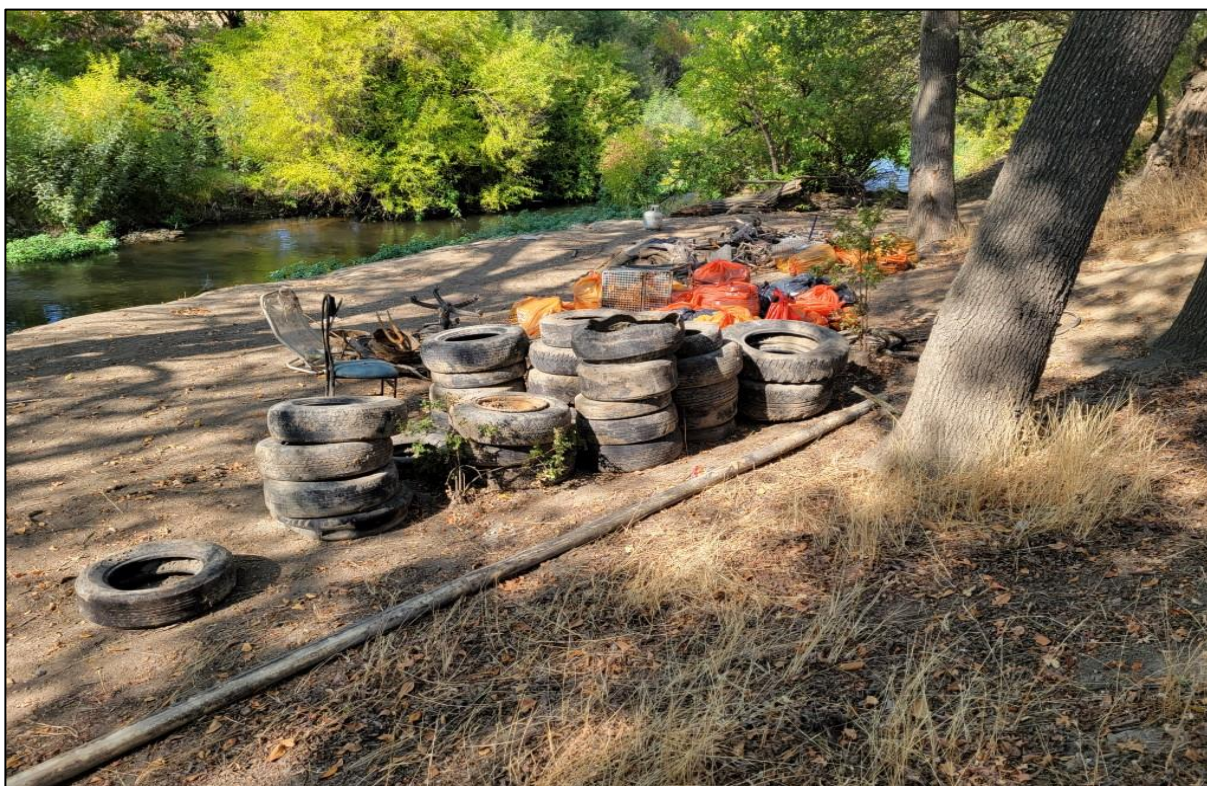
Photo 9. Horses removed thirty-two embedded tires from metric site at Arden-Garden bridge. Photo by Kathy Kayner.

Tires are inevitably embedded in the sediment; once full of sand and mud, a car tire and rim can weigh 100 lbs, and a truck tire over twice that (Photo 9). They are very difficult to remove by hand, and can take over an hour. Using the horses, however, made this task simple and easy (Video 3). Logging tongs were attached to a tire, and once the pull rope was tightened, the tong's jaws securely dug in. The tire was dragged up the bank where its sediment was removed, and then it was pulled to the staging area singly by hand or several at a time.

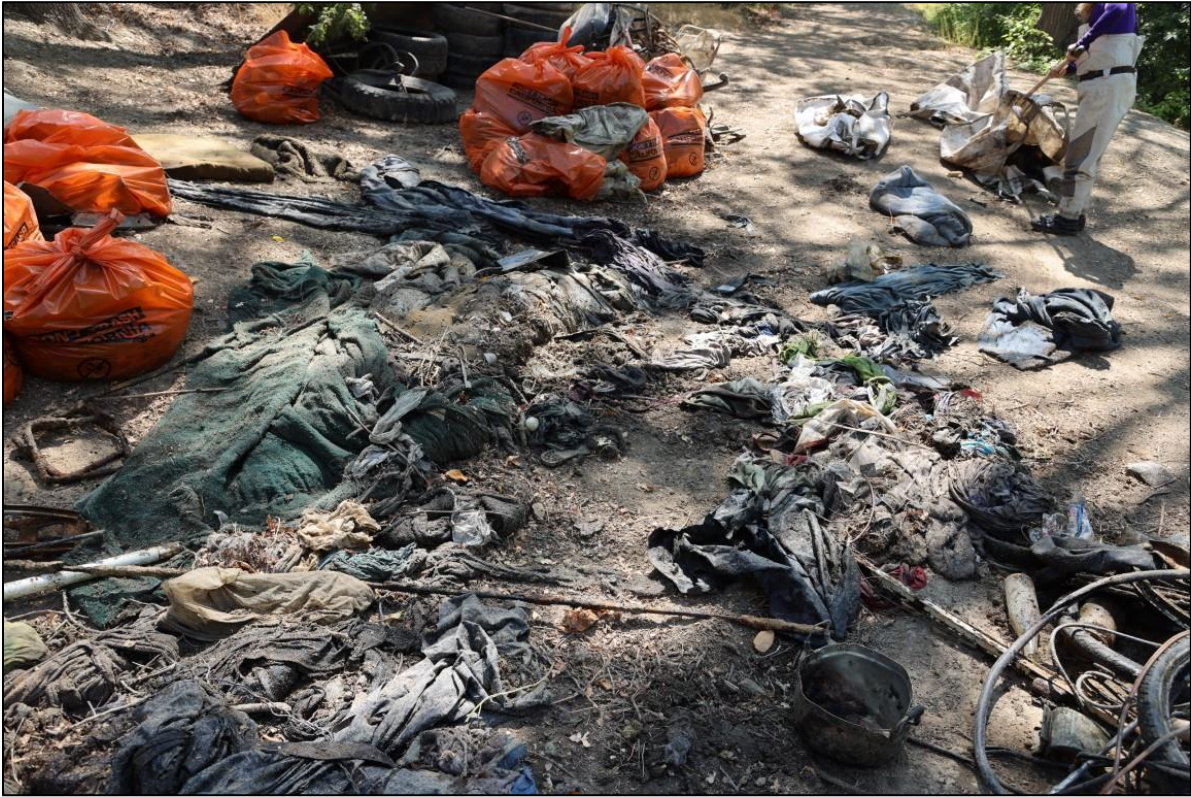
Photo 10. Example of 2622 lbs of textiles removed from Arden-Garden metric site. This material densely armors channel bottom sealing off invertebrate's access and oxygen to substrate. Photo by Kathy Kayner.

Textiles, including tents, sleeping bags, blankets and clothing; and sheet plastic, such as tarps and large bags, line the channel bottom, preventing invertebrates from accessing the substrate, and creating an anoxic “dead zone” beneath (Photo 10). Much of this material becomes trapped on shopping carts, bicycles, or tires, and fills with sediment, making it difficult to remove.

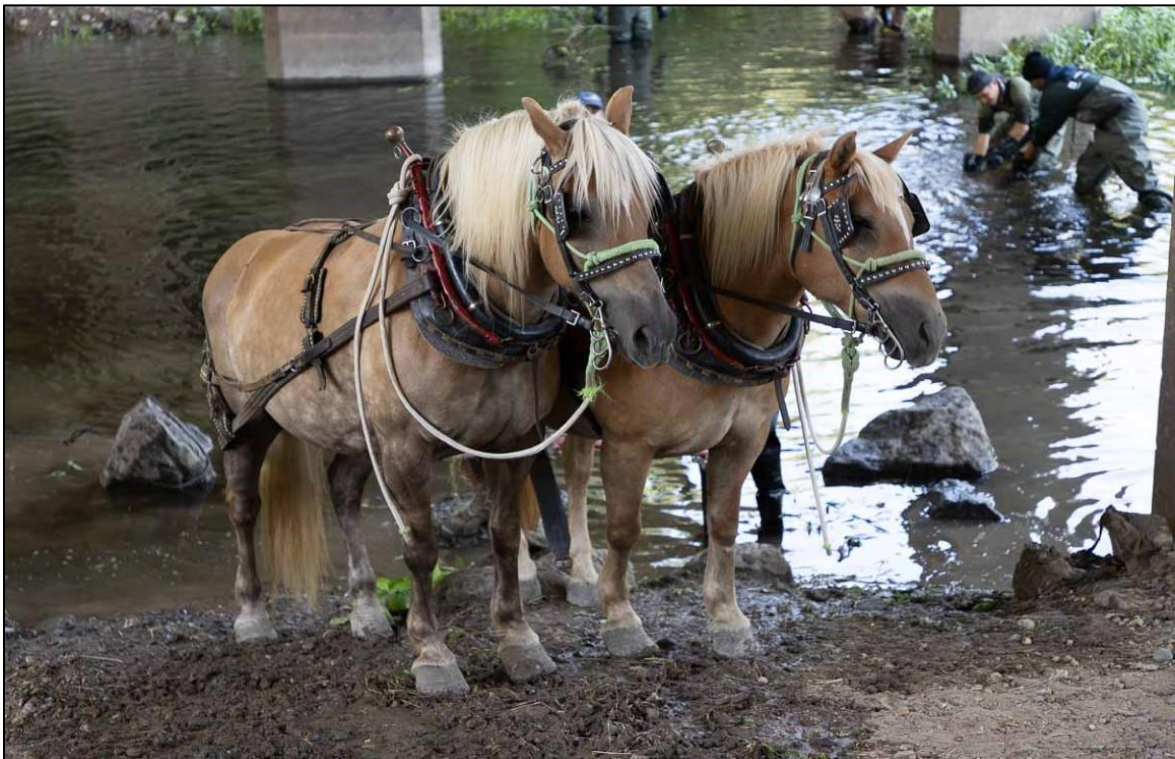
Photo 11. Belle and Star ready to haul out embedded truck tire, Northgate Bridge site. Photo by Kathy Kayner.

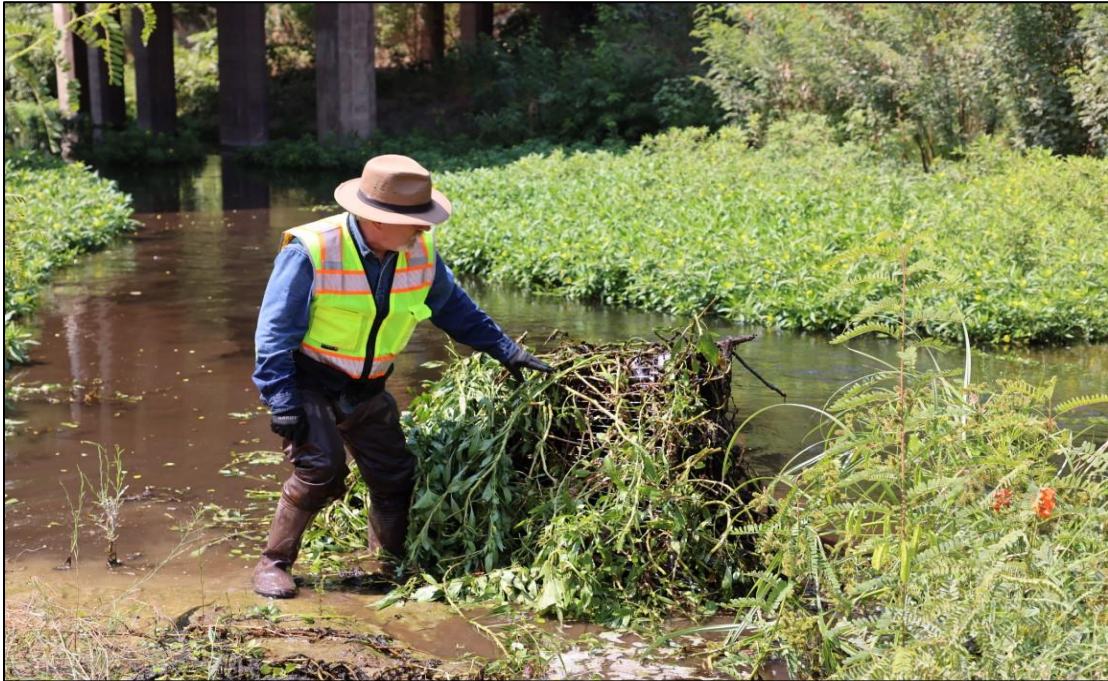
Photo 12. Shopping cart, embedded in substrate and entangled by primrose, would have been nearly impossible to remove manually. It was readily pulled by horse team. Northgate area.

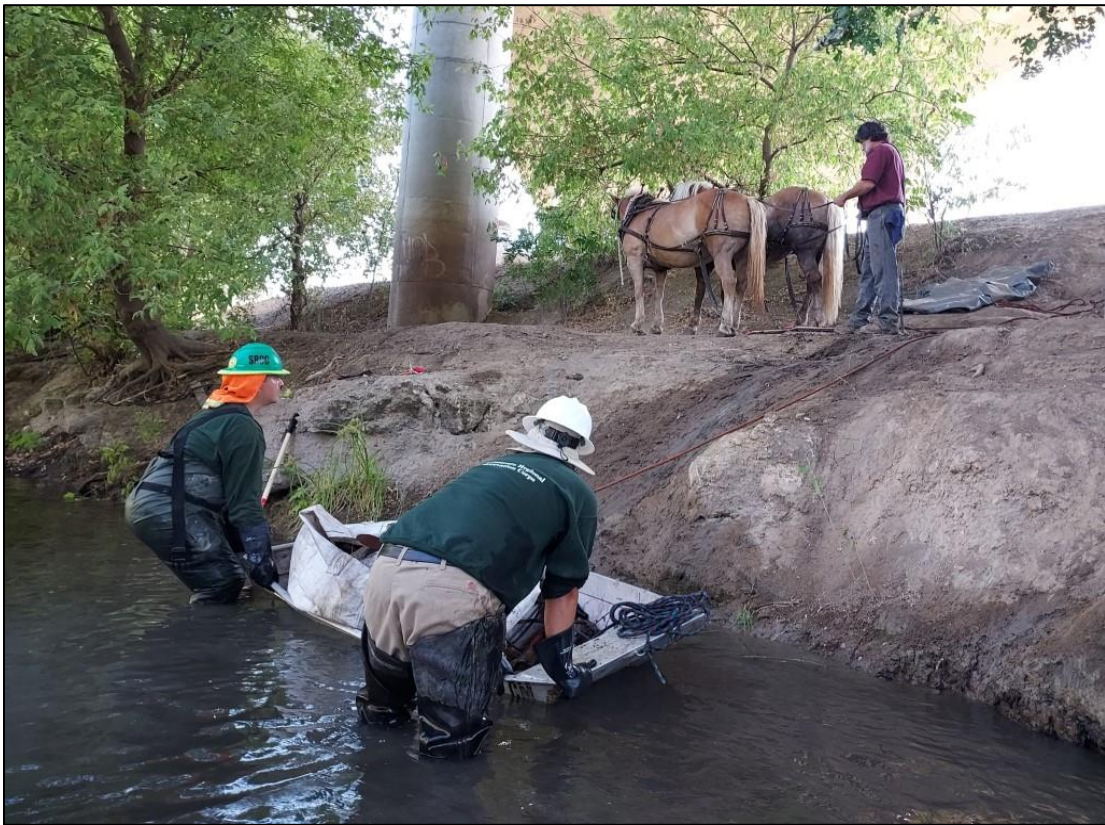
Photo 14. Removing solid debris using “super sacks” and John boat. Sack, weighing 150 lbs is attached to horse team. Note rigging for perpendicular pull. Arden-Garden metric site.

Textile materials were “fished” from the channel bottom using garden cultivators and put into woven nylon, materials-handling “super sacks” inside the 8-ft aluminum John boat (Video 4). The boat was then maneuvered to the bank, a sling threaded through the bag handles, and the bag, which could weigh several hundred pounds, was pulled up the bank by the horse team, and usually left for a few minutes to drain before it was hauled to the staging area where the contents were sorted, further drained and inventoried.

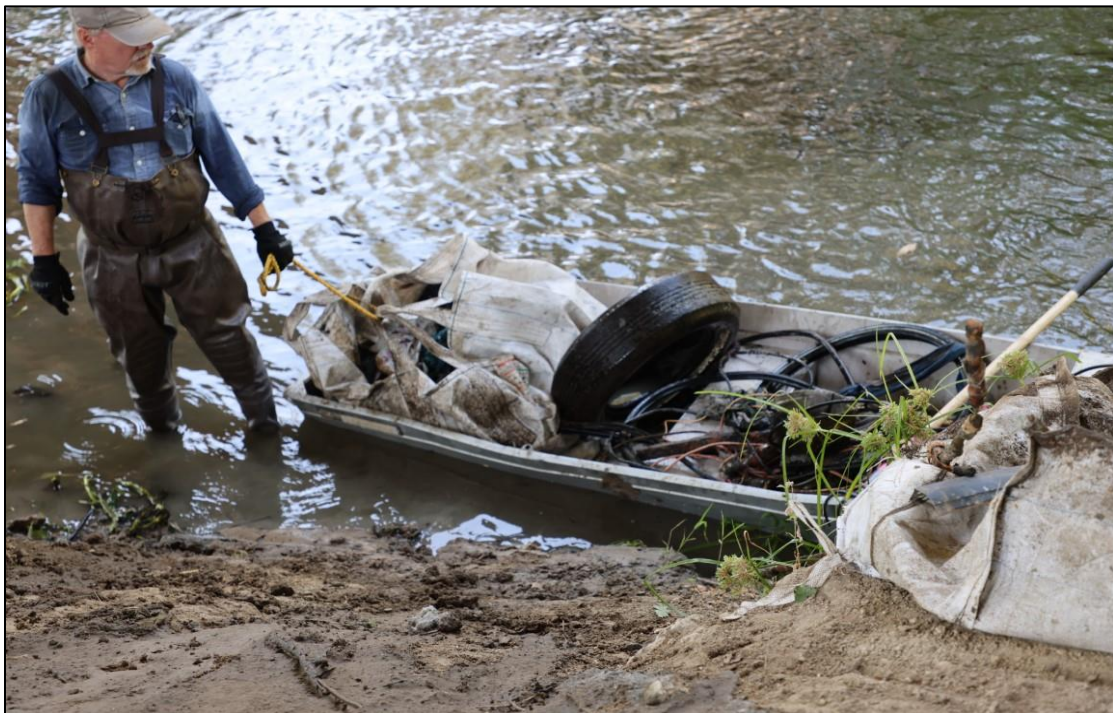
Photo 15. John boat loaded with debris and super sack. Note how low boat is sunk into water. Arden-Garden metric site. Photo by Kathy Kayner.

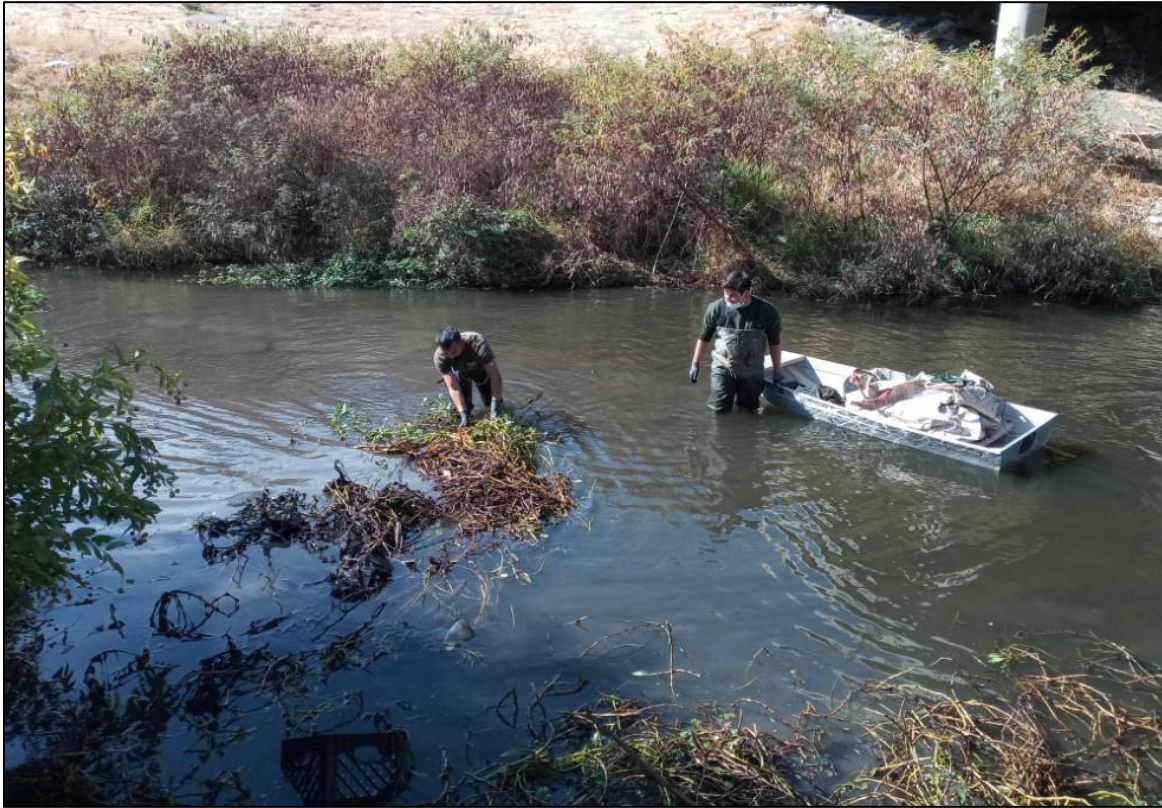
Photo 16. Removing primrose from embedded shopping cart so horses can pull it. Northgate metric site.

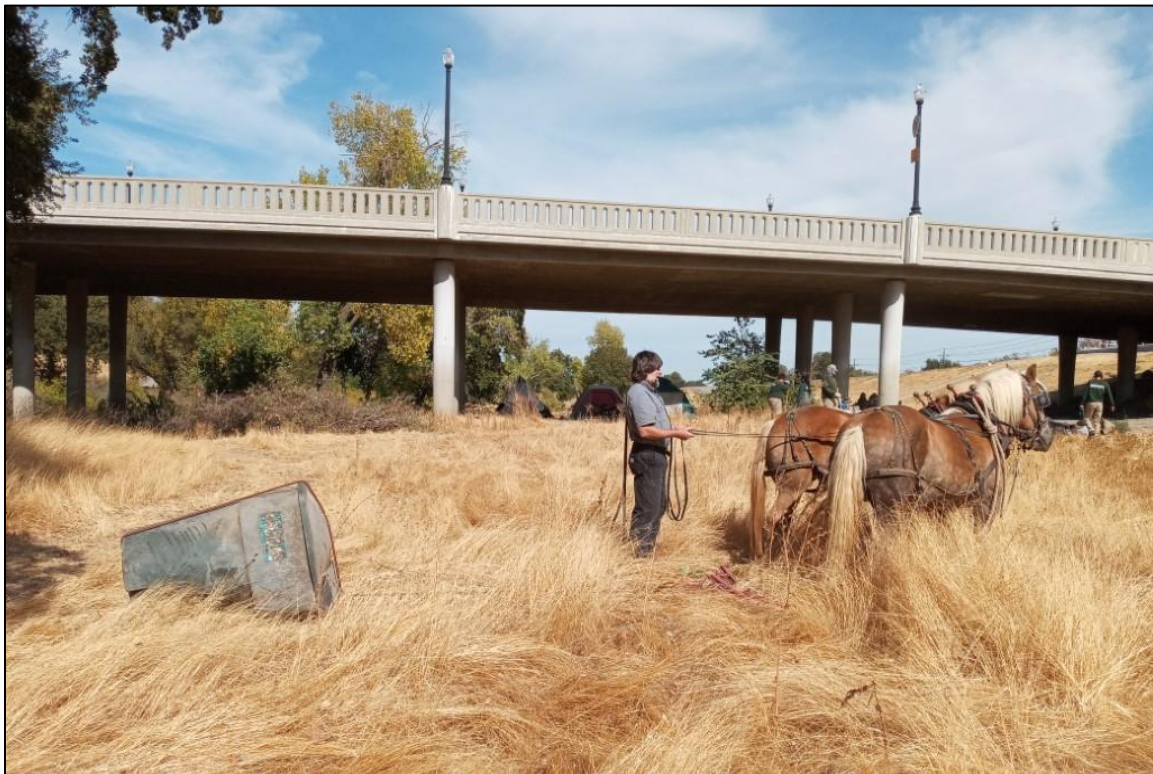
Photo 17. Scott and team pulling trash bin full of camp waste from channel. Note piled wisteria on left beneath W. El Camino bridge.

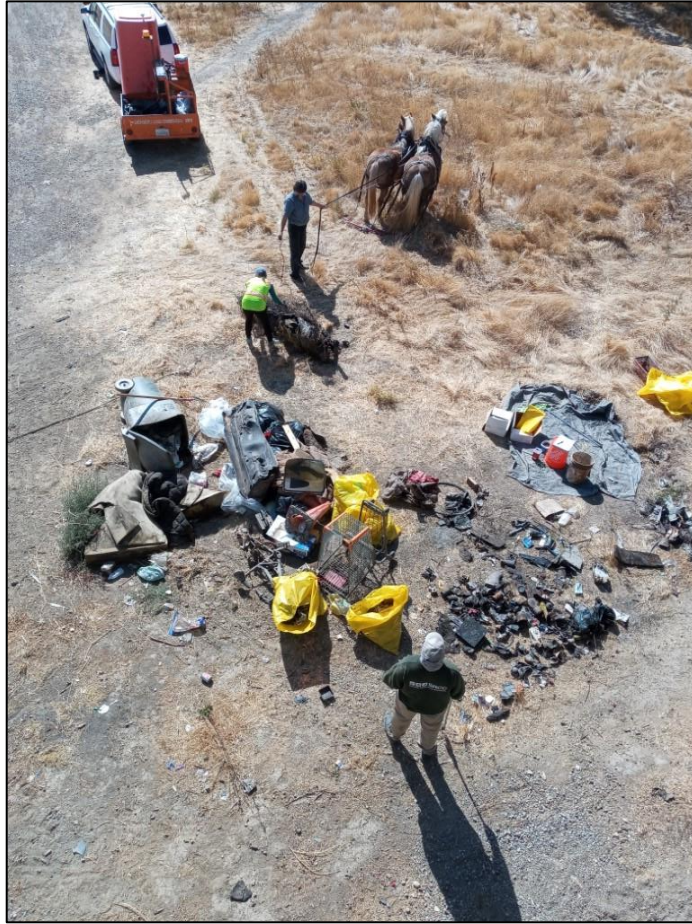
Photo 18. Staging area as seen from the W. El Camino bridge. Debris is sorted, catalogued, bagged, weighed, and the volume measured.

Once in the staging areas, the debris was placed on tarps where it was sorted and allowed to drain. Classes of debris, such as textile (being particularly problematic ecologically), were tallied on field sheets, then bagged, measured using the metal tape, and weighed with a 100-lb digital scale. Data were recorded on the field sheets and transferred to Excel files for recording and analyses.

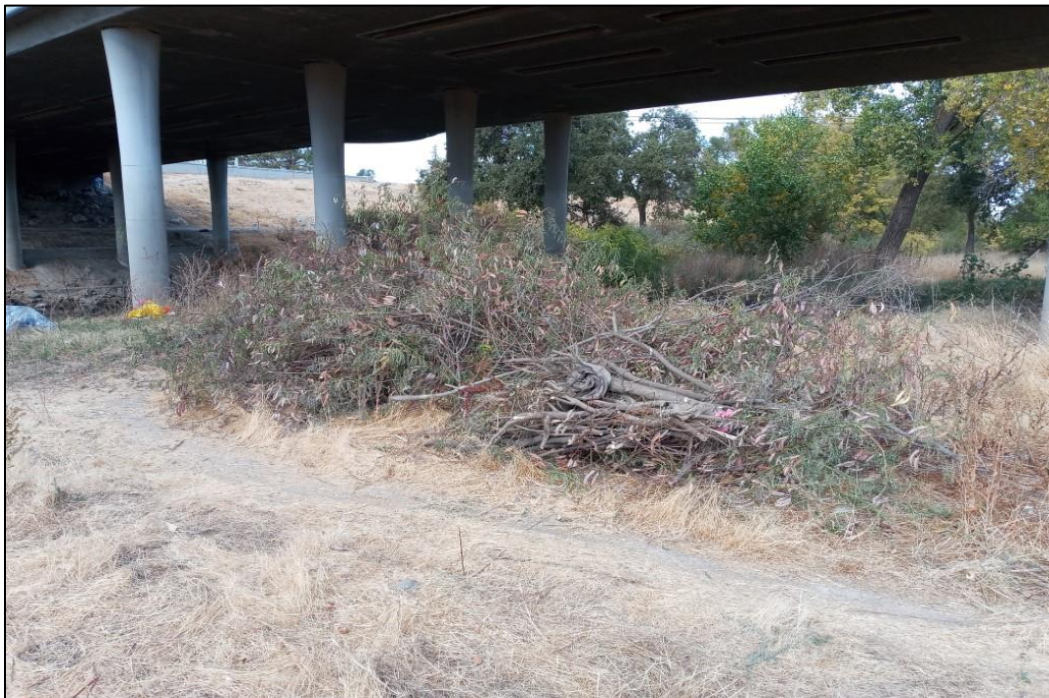
Photo 19. Staged wisteria, W. El Camino bridge. Note large trunks in foreground.

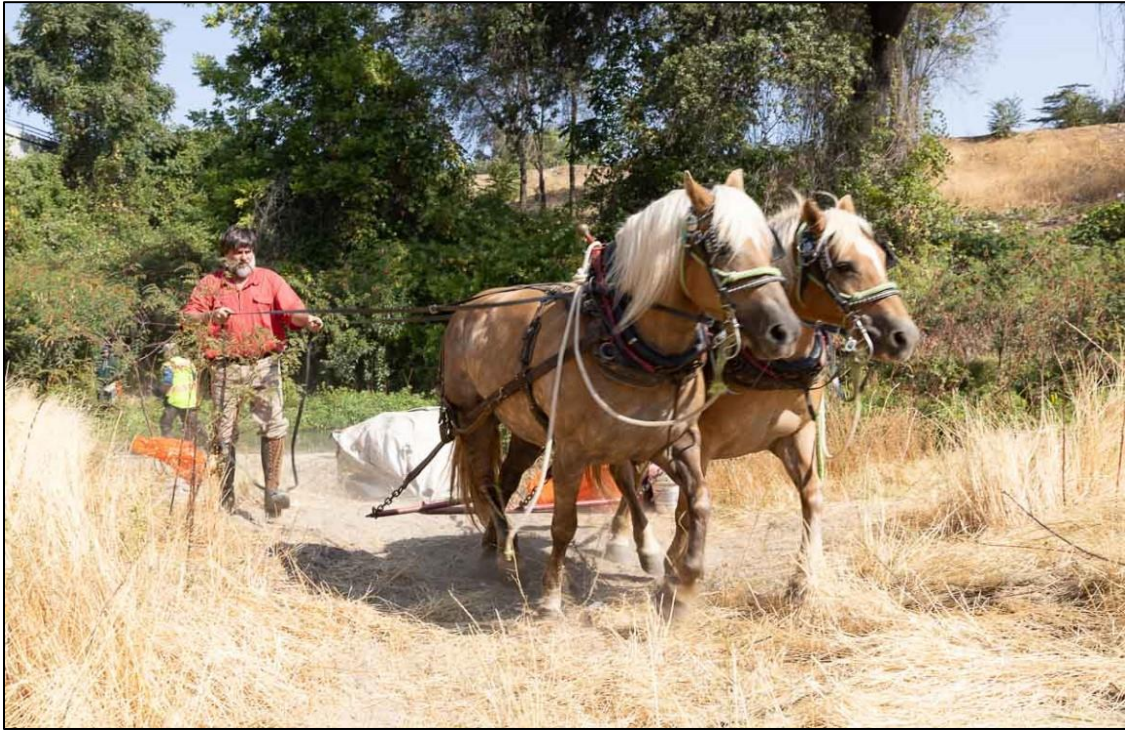
Photo 20. Belle, Star and Scott pull a sack of primrose weighing over 300 lbs. This team was essential to the Project. Not only could they remove heavy loads from the creek, they could haul it to disposal sites as far as 250 ft away. Photo by Kathy Kayner.
