Final Report:

Steelhead Creek Draft Horse Stream Channel Cleanup Project

Sacramento Regional San

Nov. 29, 2021

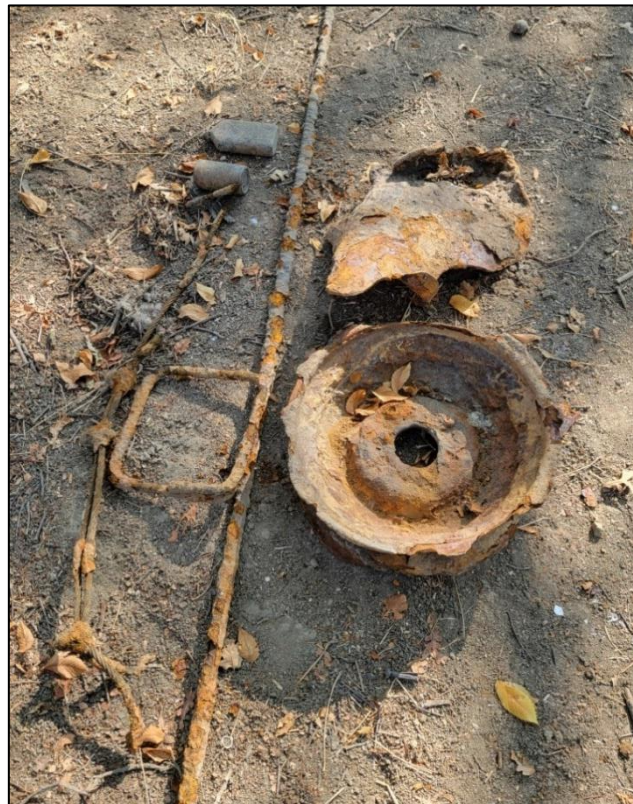
Photo 21. “Legacy debris” dumped during the 1950s and ‘60s has little effect on the aquatic habitat, aside from tires. Photo by Kathy Kayner.
